Leica ADS80 Calibration Certificate

This certificate is valid for Sensor Head Serial Number Control Unit Serial Number
SH82 **1300** **CU80**

Calibration certificate issued on **30 January 2009**

Certificate and calibration data ID **763806_1300_090130-1** Inspector
Document code 763806 **Muzaffer Adigüzel**

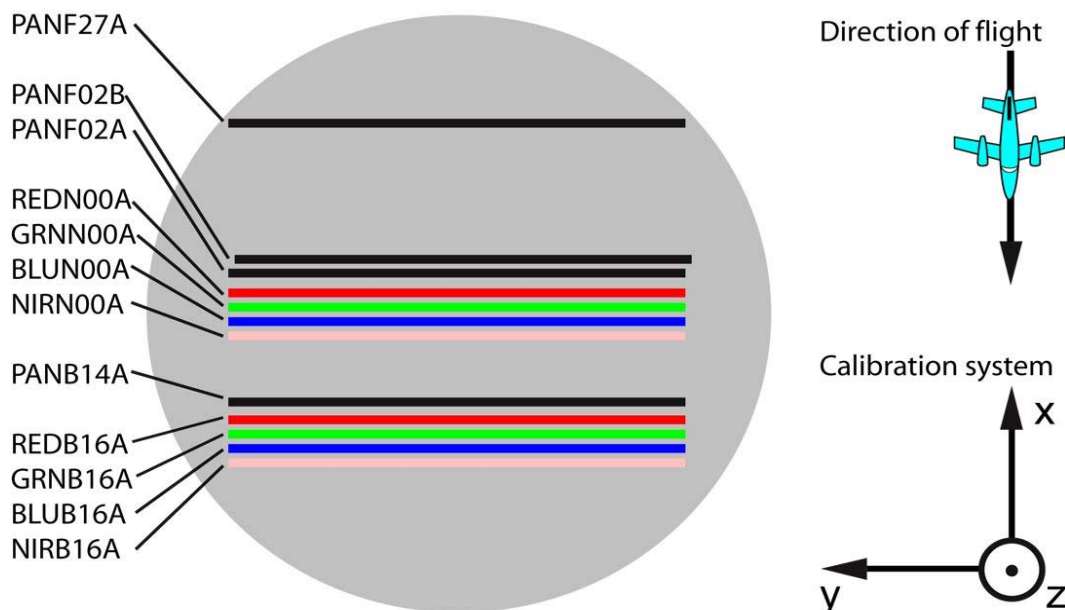
Nominal FPM layout of tested system

End pixel coordinates are center of pixel coordinates.
 Middle coordinates are between pixels 6000 and 6001.
 All values in [mm]

View from top of Sensor Head

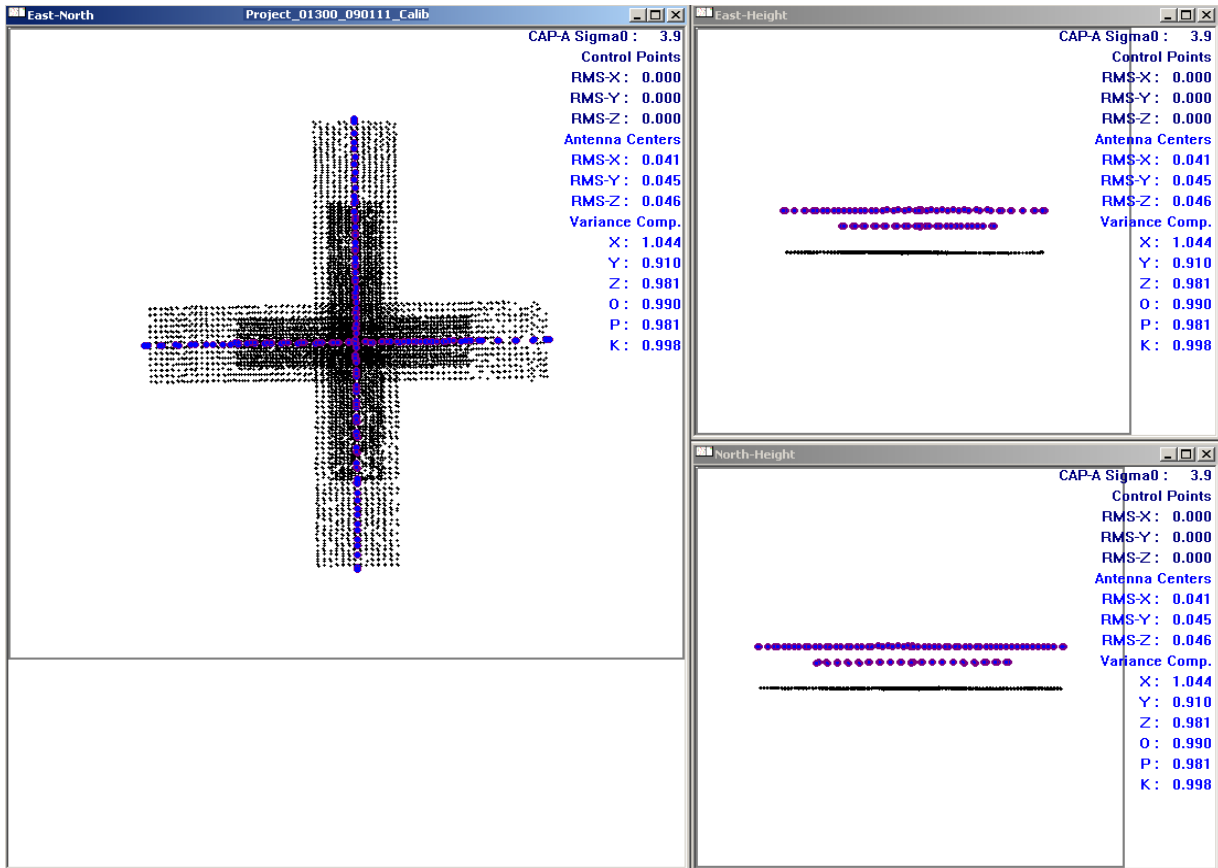
A-lines	PANF27A	PANF02A	PANB14A
Calibration method	Estimation of additional parameters in simultaneous bundle adjustment		
Sigma naught of bundle adjustment	3.9 micron		
Mean local redundancy	> 0.5		
Accuracy of calibrated apparent pixel coordinates	±2.0 micron

Final bundle adjustment result after elimination of tie point blunders and before introduction of ground control:
